Photos taken 18/5/23

### Impact Site

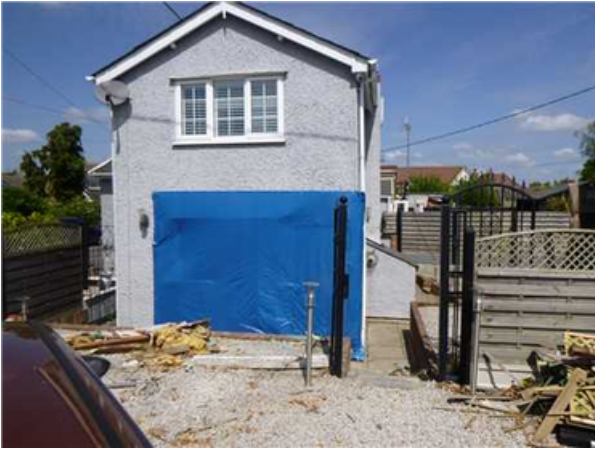
### South Elevation

Impact damage is concentrated between LH side of ground floor window and RH corner post, with minor cracking to render above opening (hairline width).

Timber-framed wall appears to date from c.1960-1980 and has been stoved in below first floor level.

No visible damage to the interior of the bedroom at first floor level.

Damage to the substructure below DPC level is unlikely due to the elevation of the driveway above the house.

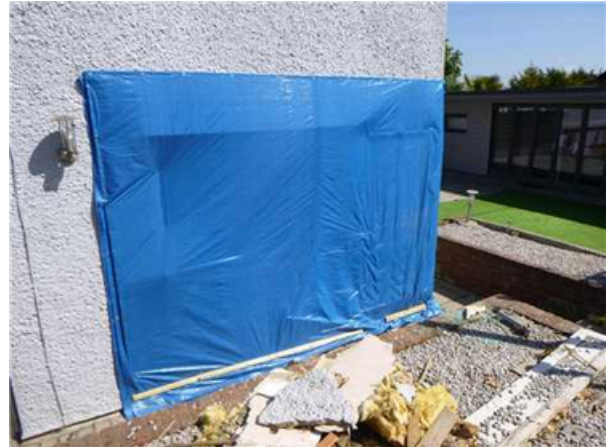
### East (side) Elevation

No major signs of structural movement, but referred cracking to cement render near corner of house caused by shock.

Repairs to the render will be needed, possibly over a large area in order to achieve a comparable textured finish.

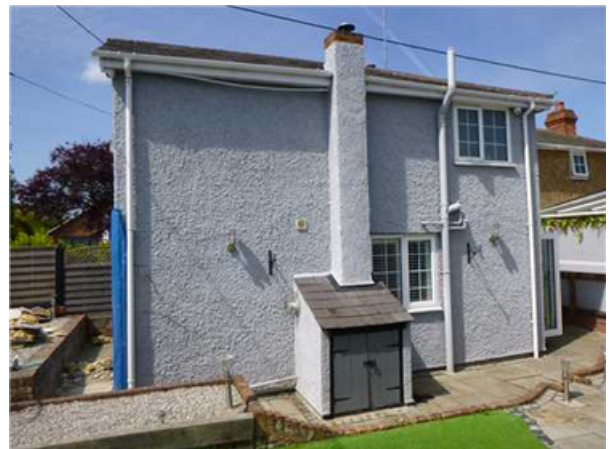
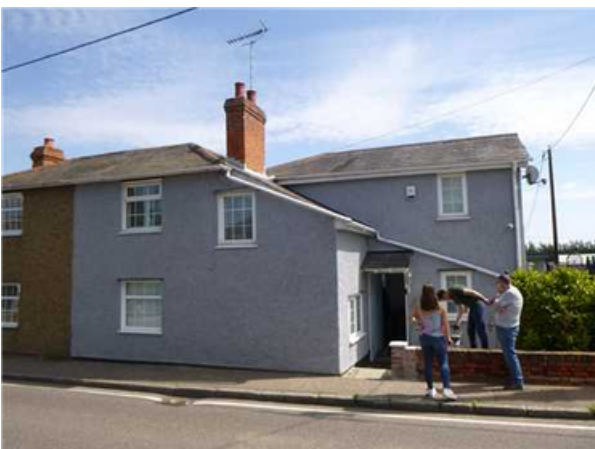
### West (roadside) Elevation

No visible symptoms of structural damage, but hairline cracks, some of which had previously been repaired, will be the result of thermal movement.

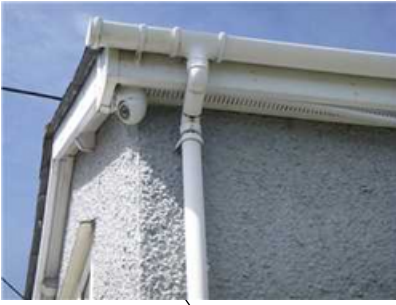
Loose trim to soffit noted, also leaking downpipe joint.

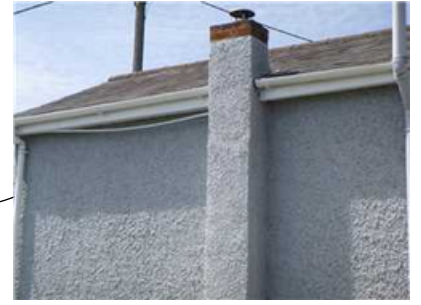
Paint marks on verge are not indicative of structural movement or damage and probably relate to replacement of fascia

Cracked render and possible damage to flank wall requires removal and replacement of render over shaded area as a minimum.

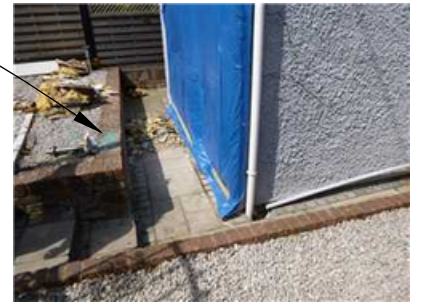
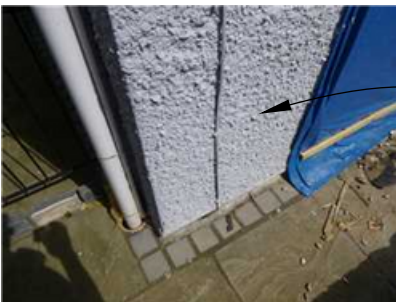
No visible damage to render in this location, but will require replacement across entire elevation in order to achieve a waterproof envelope and acceptable visual appearance. Any junctions with existing render should be cut flush and provided with a sealed movement joint with a drip detail.

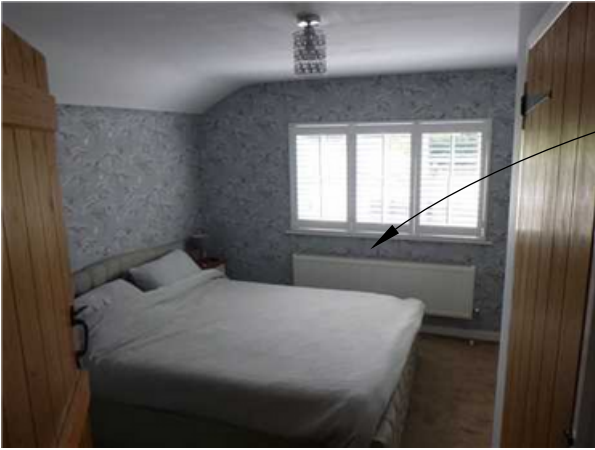
No visible damage to bedroom above

First Floor joists run parallel to gable wall

Oven unit was pushed inwards by the impact

Sink unit was pushed inwards by the impact, with the window

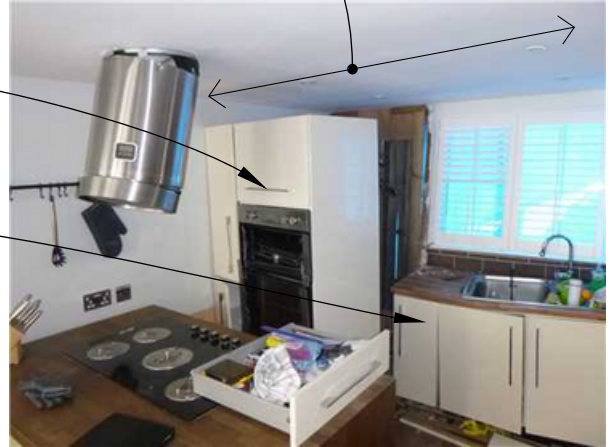
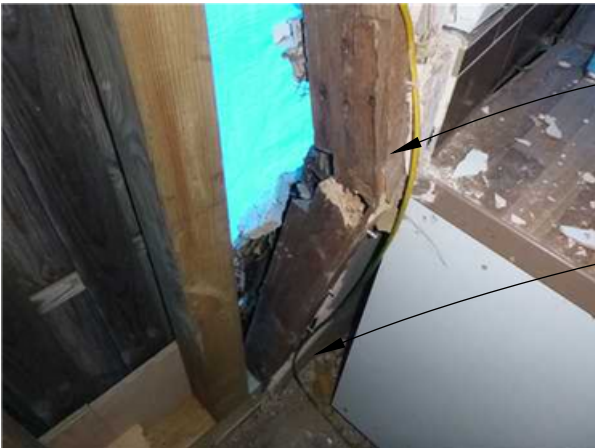
Jamb post was shoved in and ruptured

Opening in wall below worktop shows construction comprising:

- 25mm sand-cement render
- mild steel expamet lathing
- tar paper membrane
- 4" x 2" softwood stud framing
- glass wool insulation
- plasterboard & skim

Sole plate will have rotated on substructure and needs replacing on new damp-proof course
