Photos taken 18/5/23

### Impact Site

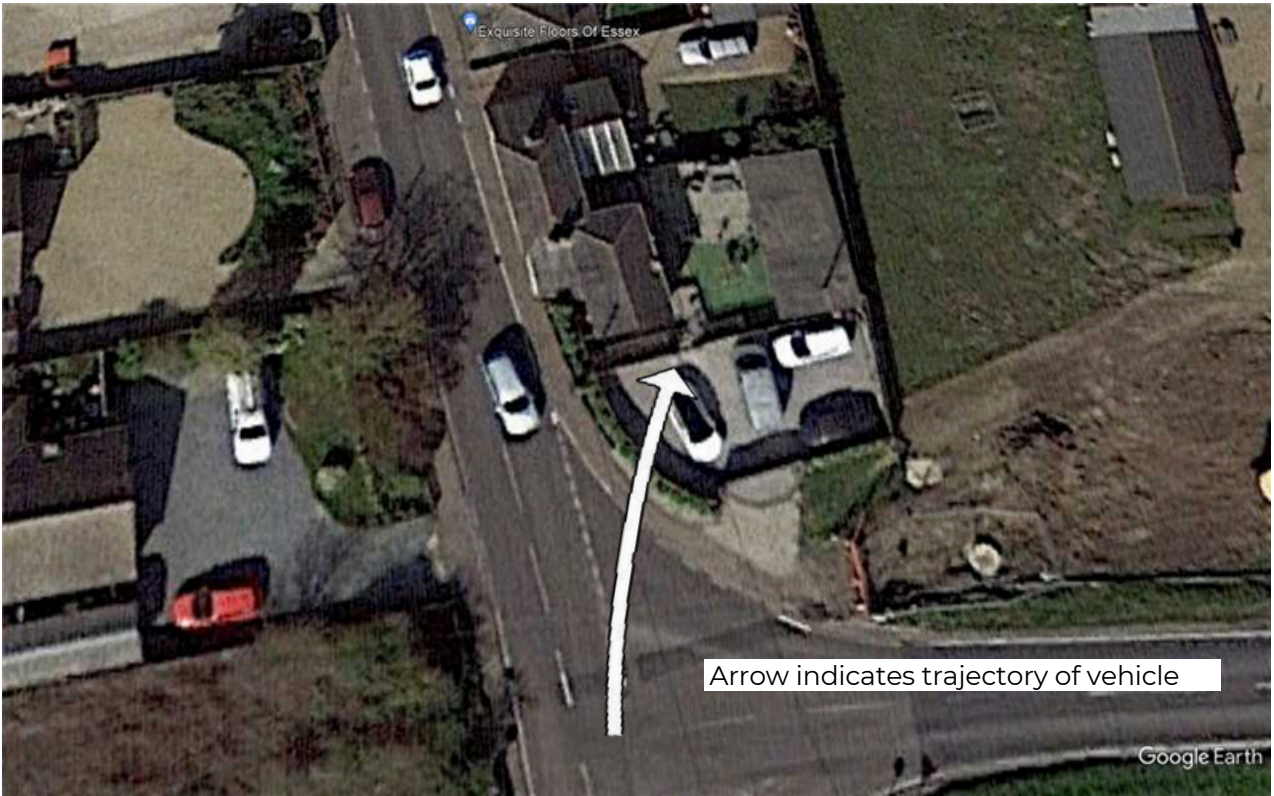
Arrow indicates trajectory of vehicle

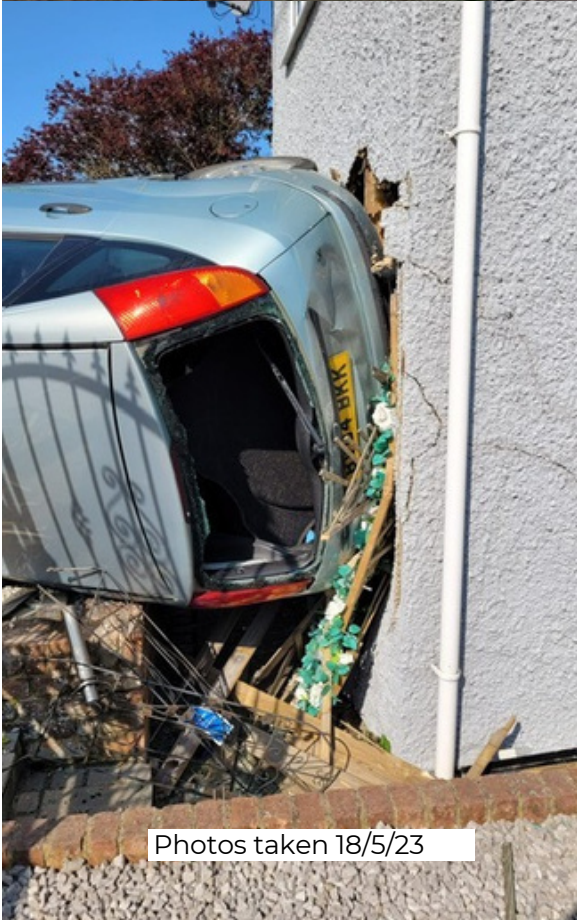
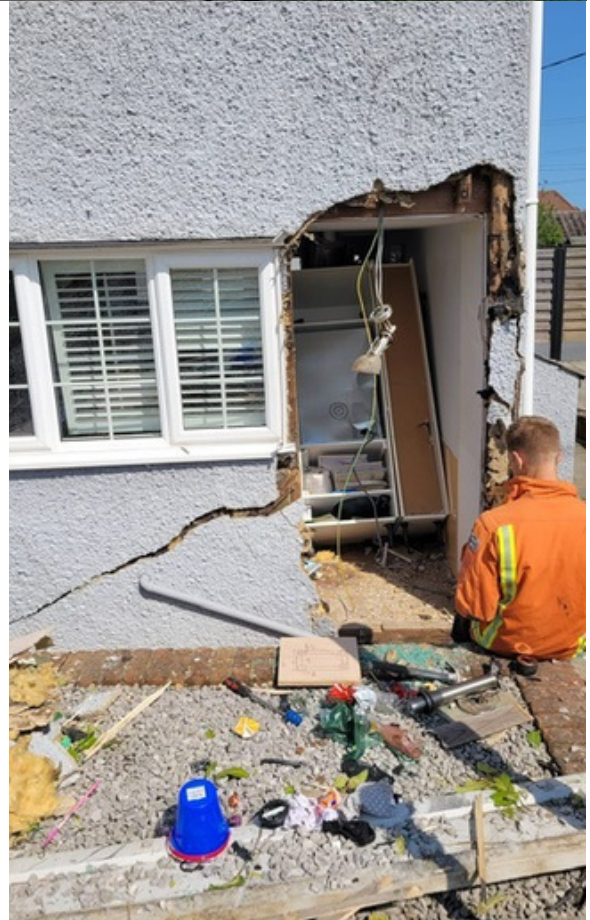
Impact damage is concentrated between LH side of ground floor window and RH corner post, with minor cracking to render above opening (hairline width).

Timber-framed wall appears to date from c.1960-1980 and has been stoved in below first floor level.

No visible damage to the interior of the bedroom at first floor level.

Damage to the substructure below DPC level is unlikely due to the elevation of the driveway above the house.
